Manhole Inspection Summary

Manhole # S43A2_003MH

Location Address: **931 E Patapsco Ave**

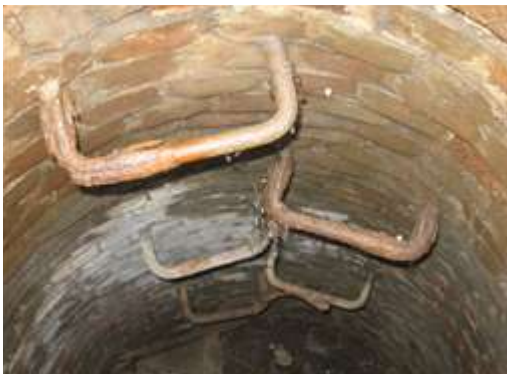
Steps

Count: **5** Missing: **0** ☐ Corroded

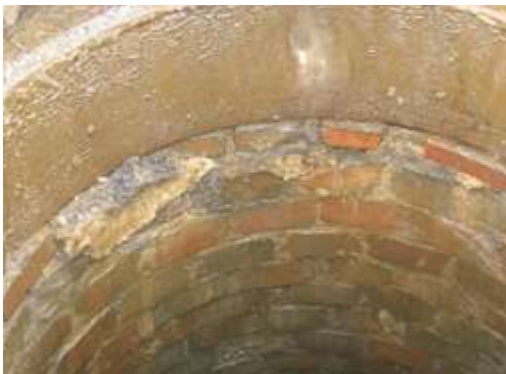
Defect 2

Condition: ☐ Sound ☐ Cracked ☐ Root Intrusion ☒ **Loose Brick** ☐ Deteriorated

Infiltration: ☐ None ☐ Joint ☐ Cracks ☒ **Mortar** ☐ Roots ☐ Wall

Loose bricks/mortar

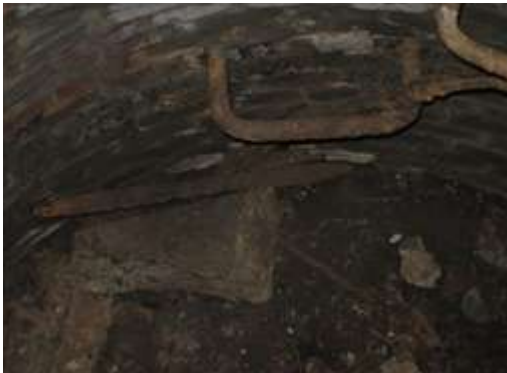
Defect 1

Large debris

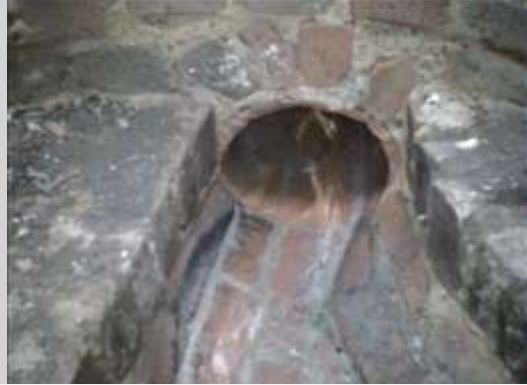
12 O'Clock Outflow

8 in. Circular Gravity Sewer
Pipe Out @ 12 O'Clock

Pipe Height: **7.2** (in.) Rod and Bar (Angled)
Pipe Material: **Clay** ☐ Pipe Lined
Invert Depth: **9.60** (ft.) Flow Characteristics: **Fast**
Deposits: ☒ None ☐ Mud ☐ Sludge ☐ Debris ☐ Grease
Silt Depth: (in.) Deposits Extent:
Infiltration: **None** Pipe Seal Cond: **Sound**

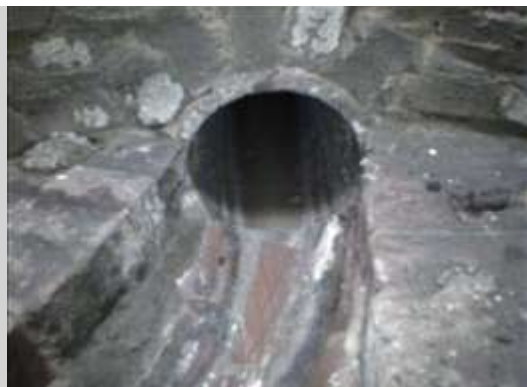
3 O'Clock Inflow

8 in. Circular Gravity Sewer
Pipe In @ 3 O'Clock

Pipe Height: **9.6** (in.) Rod and Bar (Angled)
Pipe Material: **Clay** ☐ Pipe Lined
Invert Depth: **9.30** (ft.) Flow Characteristics: **Fast**
Deposits: ☒ None ☐ Mud ☐ Sludge ☐ Debris ☐ Grease
Silt Depth: (in.) Deposits Extent:
Infiltration: **None** Pipe Seal Cond: **Sound**

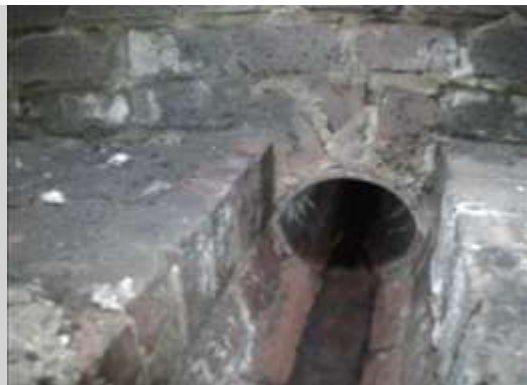
6 O'Clock Inflow

6 in. Circular Service Sewer
Pipe In @ 6 O'Clock

Pipe Height: **7.2** (in.) Rod and Bar (Angled)

Pipe Material: **Clay** ☐ Pipe Lined

Invert Depth: **9.56** (ft.) Flow Characteristics: **None**

Infiltration: **None**

Pipe Seal Cond: **Sound**
